Title:	Plates are not Put Correctly on Transfer Station	ID:	
		0318	
Date in:	Response:	Model:	Author:
2008-01-15	2008-01-15	-	CMa

Slide Station Horizontal Position Adjustment

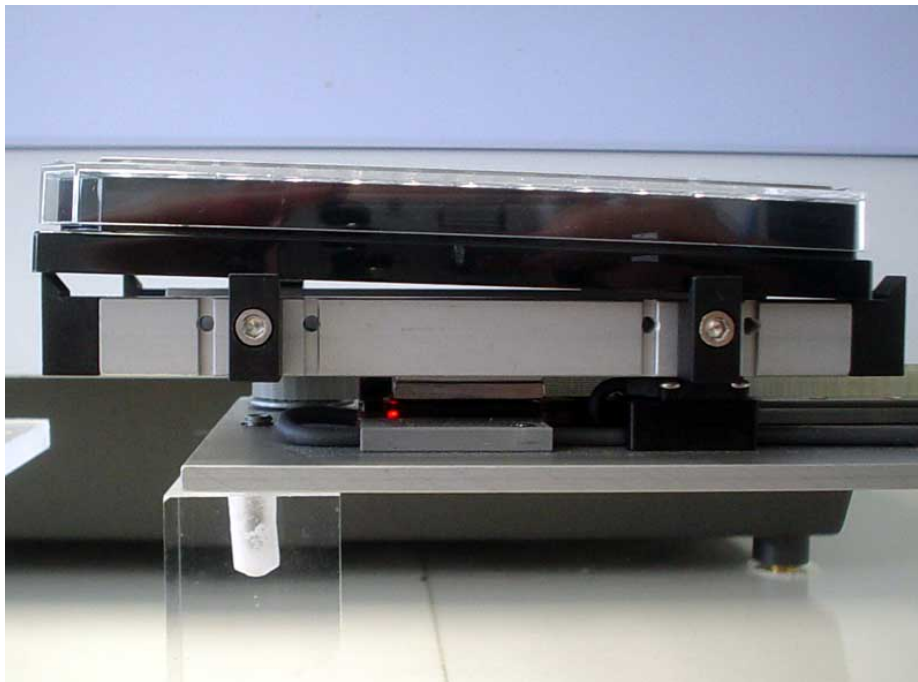
Error: The plate is put to far out.

The inner position of the Slide Station is to close to the back plane or the Gate. Most likely the machine was pushed inwards.

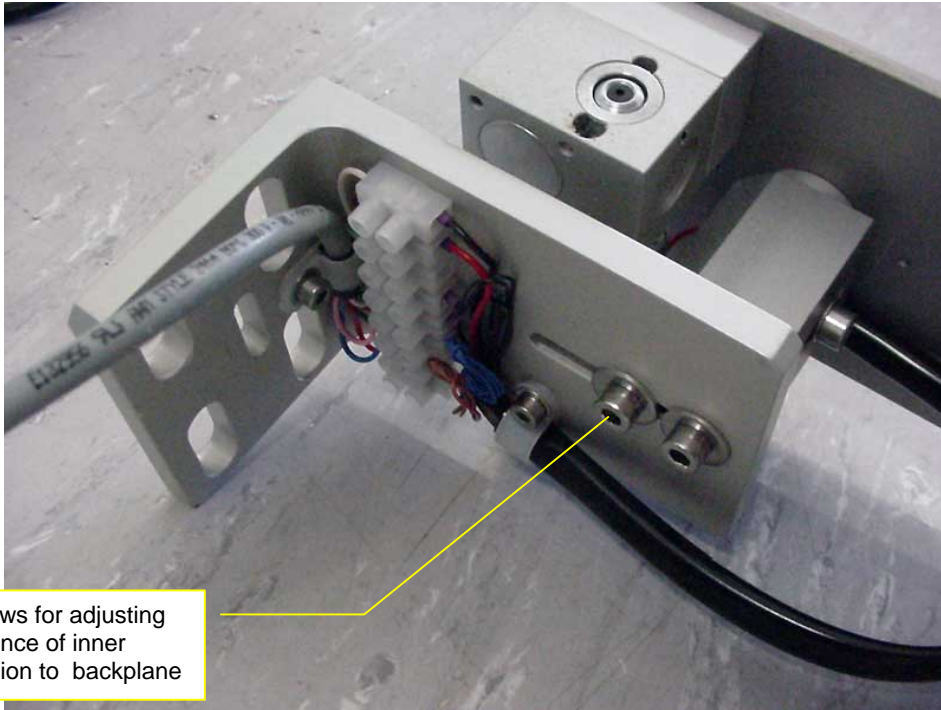
The upper part of the Transfer Station can be moved horizontally after loosening the two screws underneath the holder bracket.
