Title:	Plates are not Put Correctly on Transfer Station	ID:	
		0335	
Date in:	Response:	Model:	Author:
2008-01-15	2008-01-15	-	CMa

Slide Station Horizontal Position Adjustment

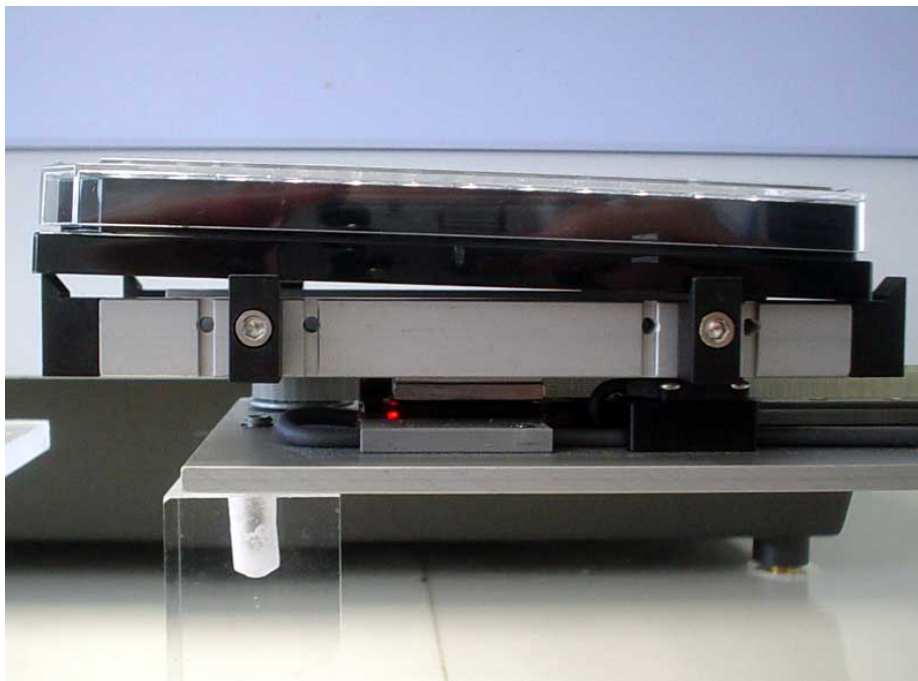
Error: The plate is put to far out.

The inner position of the Slide Station is to close to the back plane or the Gate. Most likely the machine was pushed inwards.

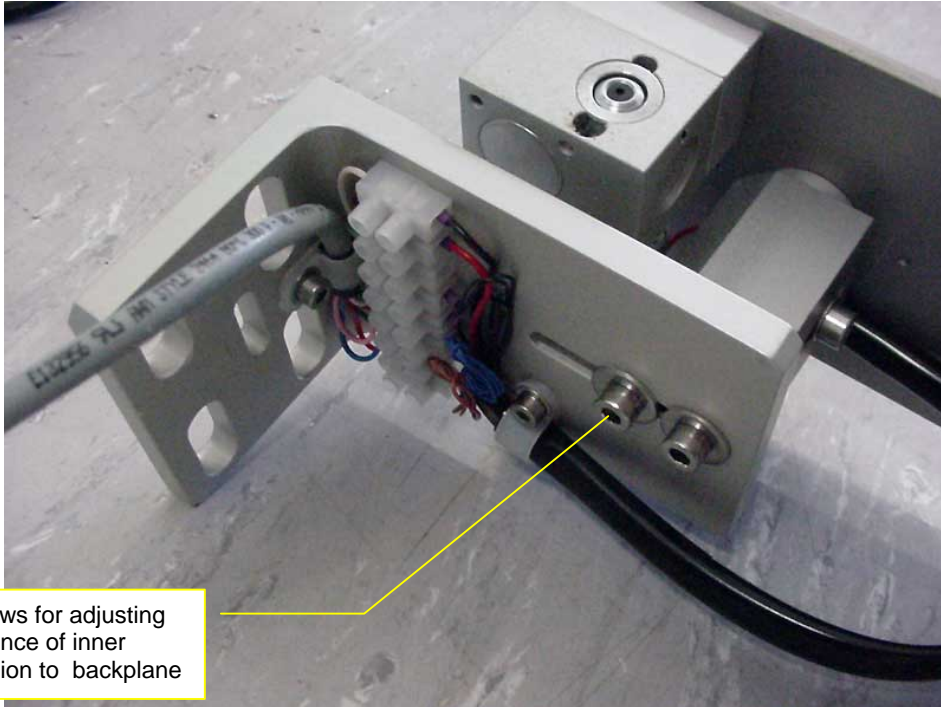
The upper part of the Transfer Station can be moved horizontally after loosening the two screws underneath the holder bracket.
