Title:	Condensation on Glass Door			ID:
				0055
Date in:	Response:	Model:	Author:	
2003-04-23	2003-04-23	STR44	CMa

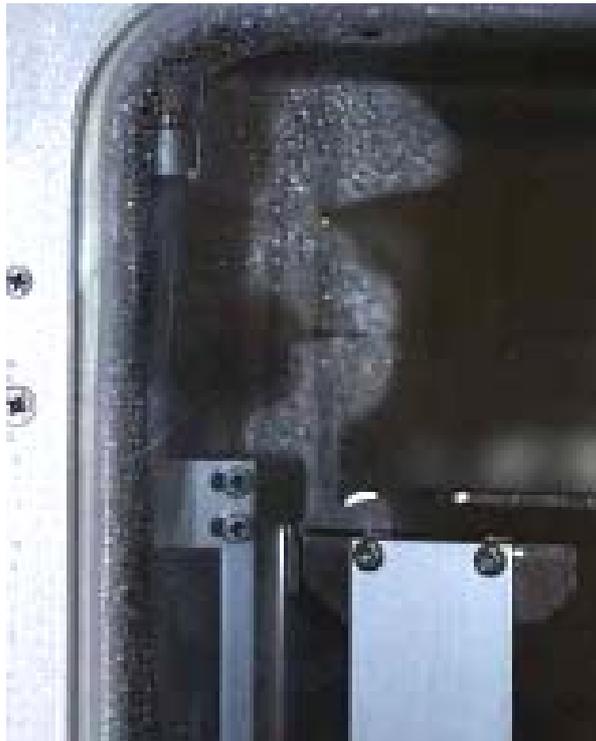
Are attached photos concerning the 44 unit we have: strong condensation was observed on the door. Please comment and tell me our you what are your recommendations.

- What is the humidity setting (RD DM893)?
- Looks that the glass door sealing is not tight. Use paper to check if gasket touches the inner surface of the glass door. Put paper between the gasket and the glass door and move paper along the gasket. Check for resistance. If gasket does not seal the glass door lock has to be tightened.
- Some small amount of condensation may occur. Specially when the outer main door is frequently opened.
